UNIVERSITY OF SUSSEX

THE MEETING
HOUSE ORGAN

REPORT & RECOMMENDATIONS

FEBRUARY 2013

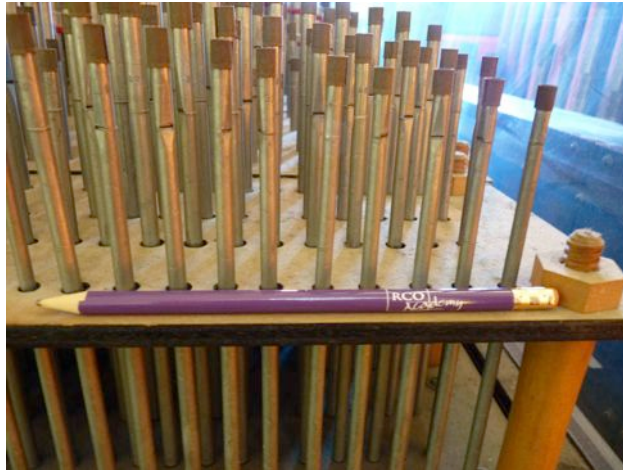
*Great
smallest
pipes
& dust*

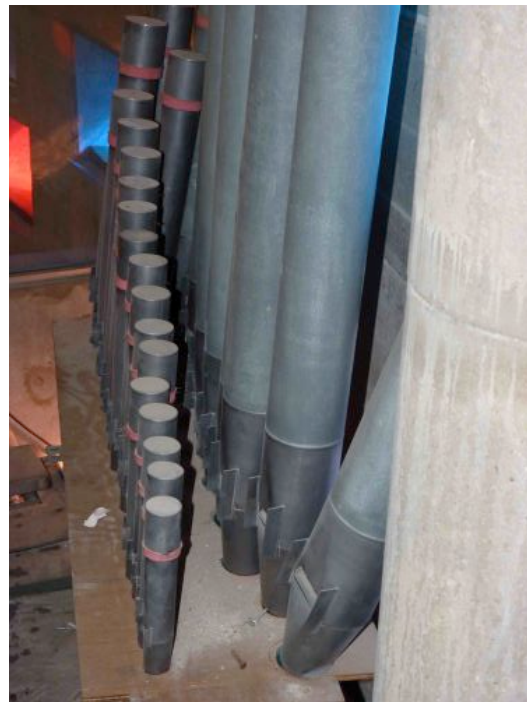
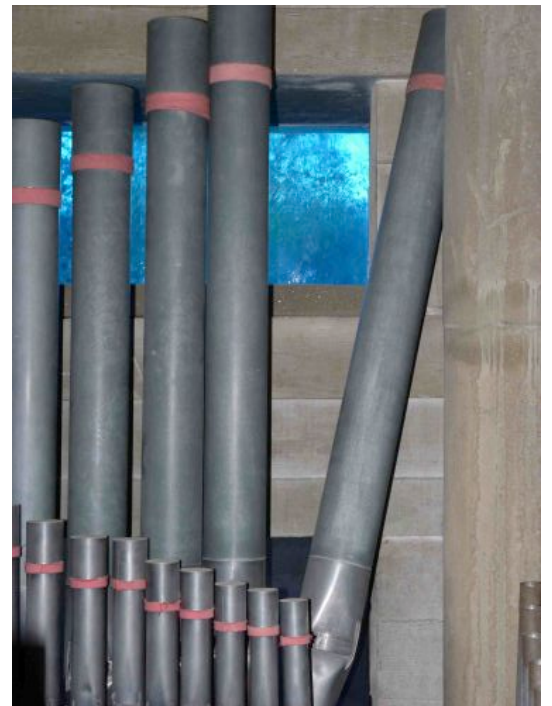
5. The supports for the 1976 Pedal Flöte chest are very poorly made, being of Dexion (steel racking); the chest itself has pipes on blocks and odd pieces of plywood. Bottom C has fallen over as the foot has collapsed. This is not remotely up to the standard of the rest of the organ.

*Pedal Flöte
pipes
sagging;
bottom
note
collapsed*

5. Replace the foot on bottom C of the Pedal Flöte.
6. Revoice the Dulzian to establish evenness of tone. This needs more detailed inspection first to decide what to do.

7. Replace Flöte unit chest with a similar but better-made chest, allowing correct space for the pipes to stand, the largest pipes supported with a half-moon rack. Consider carefully its placement and stand it on wooden supports fixed to the wall or floor – not using Dexion as at present.

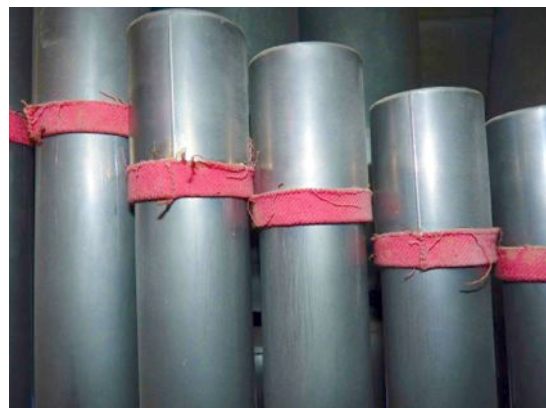
3. I am concerned about the red cloth used to seal the canisters of the 1976 Pedal Flöte as it will shortly become unsound.
4. The Swell 16ft Dulzian is irregular in tone and amplitude.

*Flöte
canister
cloth –
poor*

1. Remove all pipes.
2. Clean the pipes extremely carefully to avoid disturbing the mouths and toes.
3. Fit new tuning slides if the budget allows.
4. Check canisters and stoppers for soundness and re-pack as necessary.

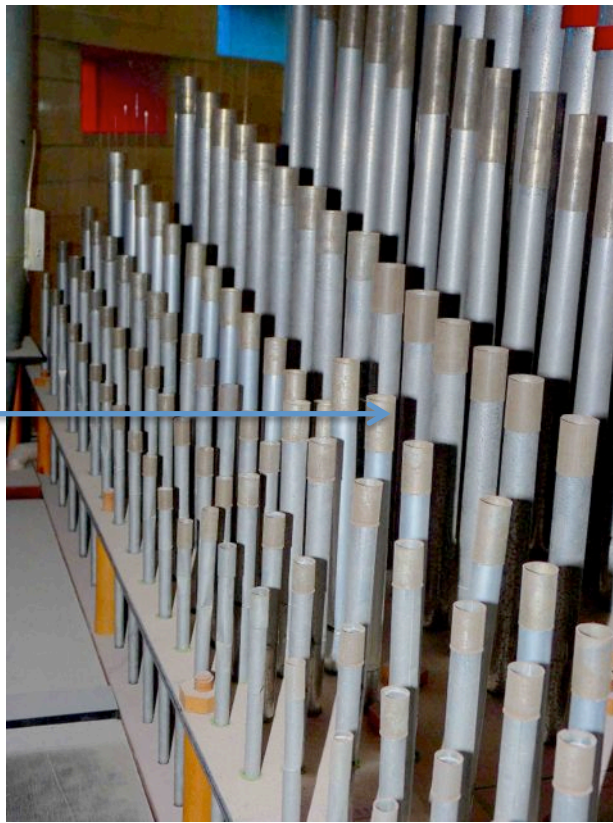
9. The tin-plate tuning slides on most of the flue pipes are oxidised with age and through their 'rusty' colour mar the appearance of the tops of the pipes. Consideration should be given to fitting new bright tuning slides throughout, to restore the pipework to its original appearance.

Tuning-slides on pipes – rusty

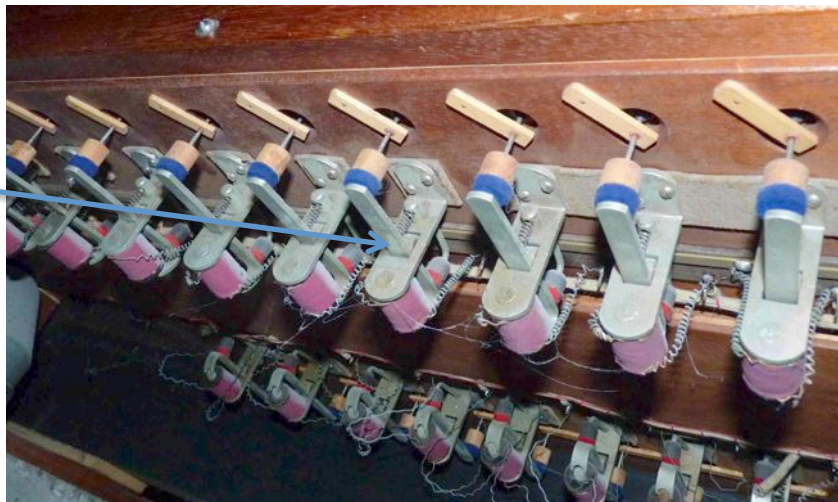
Soundboard lever-magnets – worn pivots

1. Lever-magnets (Laukhuff) operating the underactions
2. Manual key contacts
3. Pedal key contacts
4. Stop-key units (Laukhuff)
5. Thumb piston units (P&S)
6. General cancel piston (P&S)
7. Toe piston units (Laukhuff and Kimber-Allen)
8. Piston relays (Laukhuff)
9. Piston setter-board
10. Reversible pistons relays
11. Cabling throughout the console
12. Main transformer-rectifier in the organ

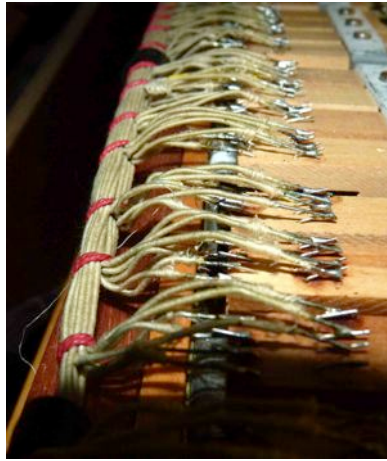
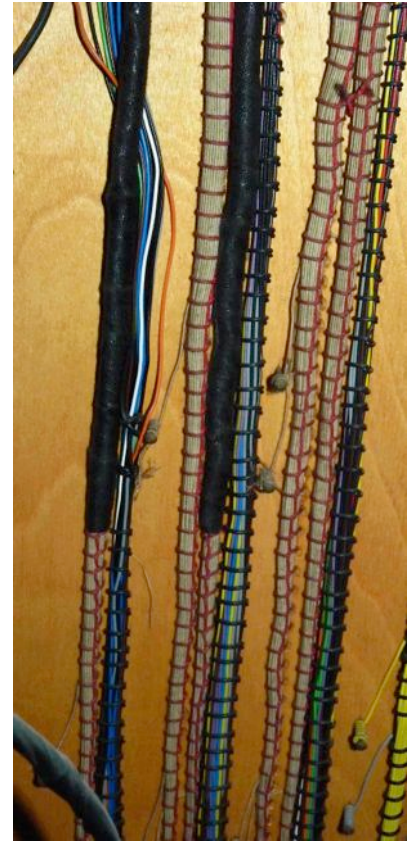
*(L & R)
cotton-
covered
wiring
in
console*

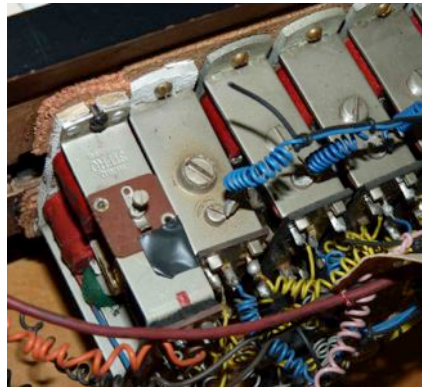
*mismatched
stop-key
solenoids
for 1976
additions*

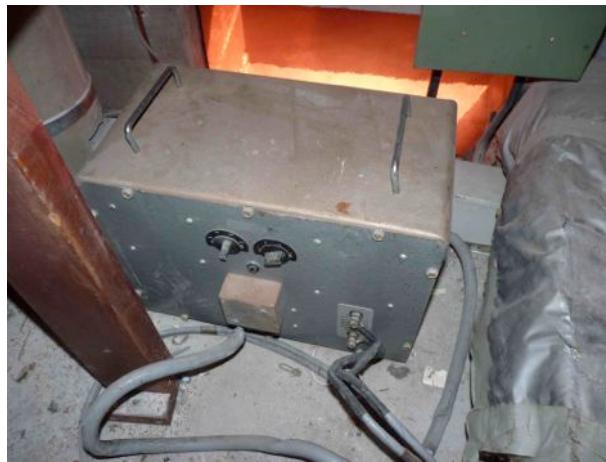
*(L) main
transformer-
rectifier
from 1966*

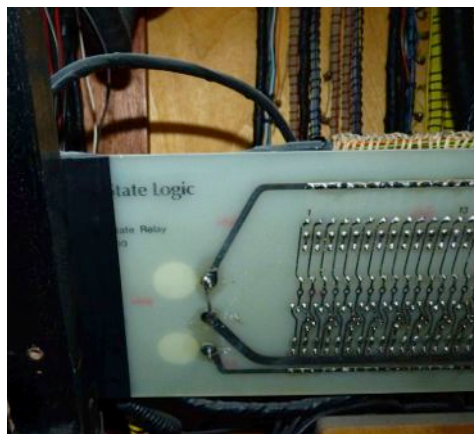
*(L) 1976
addition
piggy-
backed
onto old
wiring*

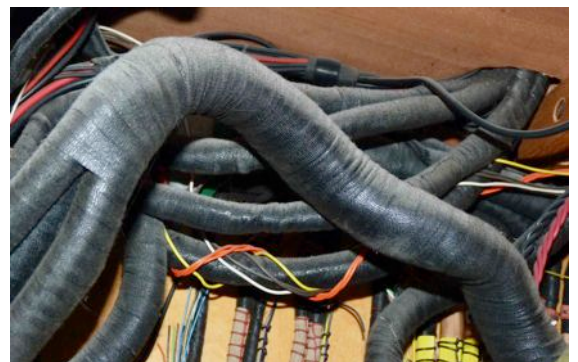
*(RH) console
wiring - tricky
to access*

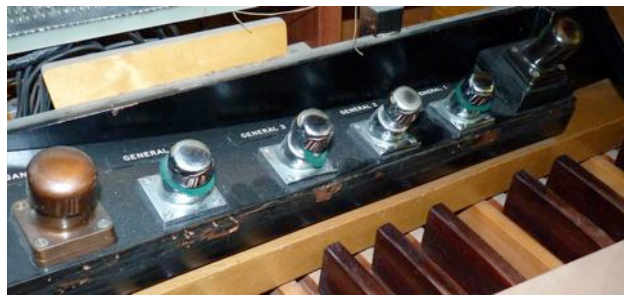
*(L) toe pistons
mismatched*

12. Toe pistons will need to be the same type as those added in 1976 as there is no toe sweep for the more elegant domed type used by GDB on their later consoles.

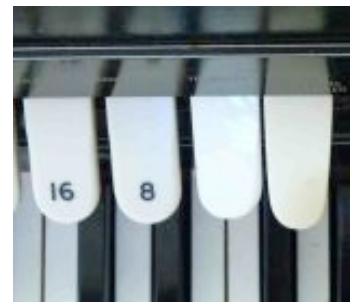
7. Two white stop-keys (added in 1976) do not match the originals.
8. The swell-pedal needs a new top surface.
9. The lock is broken and is best removed.
10. The console lighting is crude and ill-wired, as are small spot-lights to the organ itself, mounted near the console.
11. The console cannot readily be moved out for access to its components. This militates against easy maintenance.

*(R) stop keys
mismatched*

1. Refinish all painted / ebonised surfaces back to original condition.
2. Cut the key-bench back to the Great pistons from inside the Great key cheeks.
3. Remove the lock from the locking fall and make good.
4. Remove the raised piston selector panel from the top of the console and refinish the top, flush.
5. Replace the bench with a new, more solid, adjustable bench, which could have black side and back panels to match the console finish.
6. Re-cover the Swell pedal in new lino of a similar colour.
7. Refurbish the manual keys as is found necessary when taken apart. All new felts.
8. Replace the two extreme RH stop-keys with genuine white Compton blanks to match the others, or have two made specially.

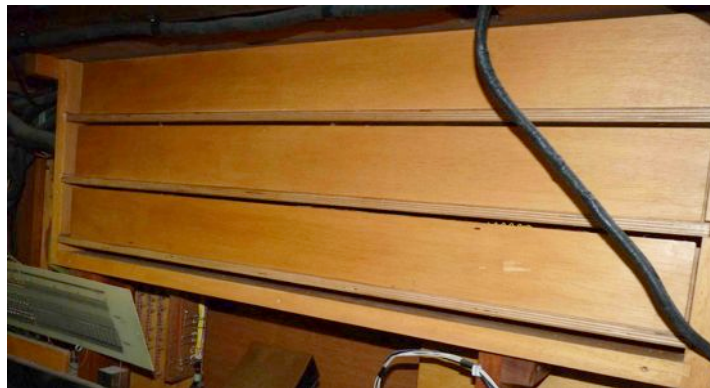
*console
relays
inaccessible*

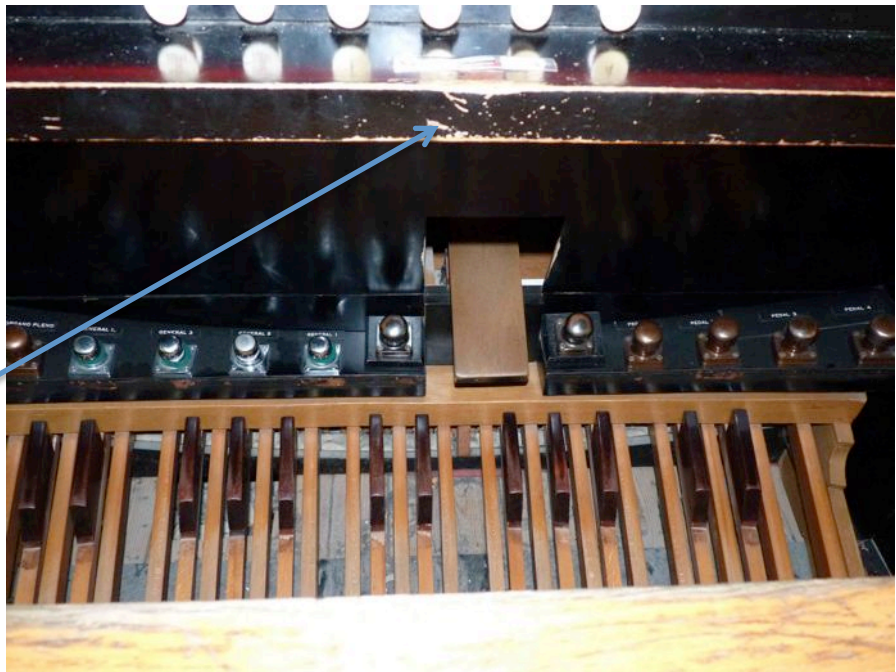
*worn
surfaces
and controls;
also note
the knee-
catching
projecting
key-bench
under the
lower
manual*

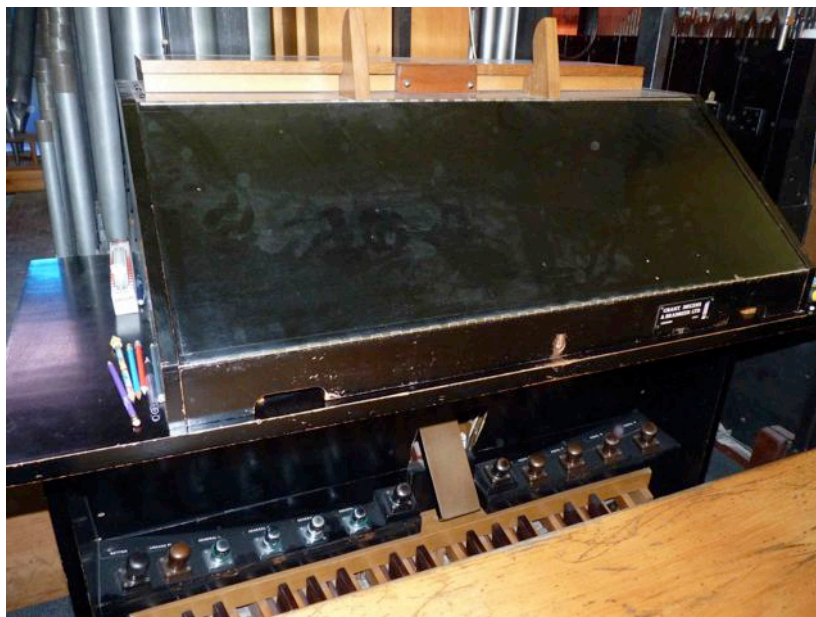
*console
closed –
note wear
to lid*

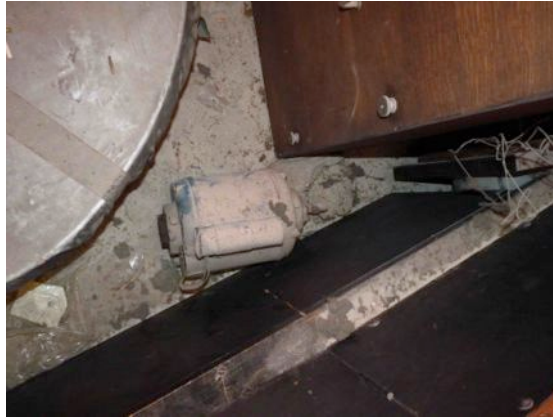
(L) original blower motor plus debris

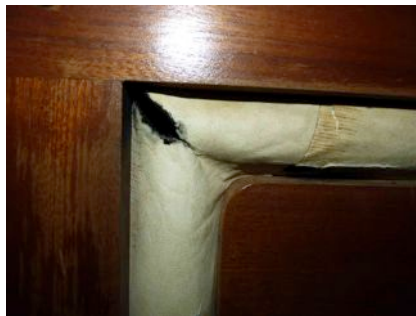
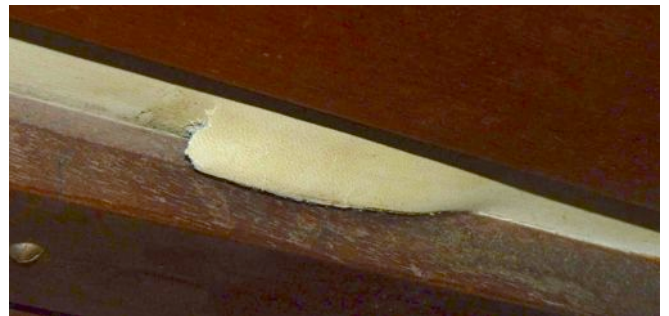
1. The leather which forms a membrane on the three Schwimmers has reached the end of its life and is failing (particularly on the Great Schwimmer). The escaping air can be heard in the body of the building.

Great Schwimmer showing burst areas

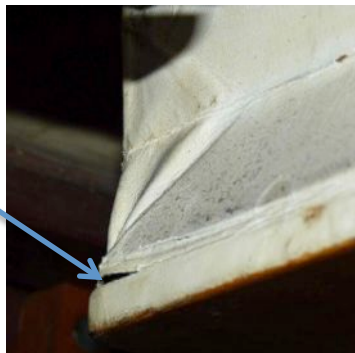
(L) Great Tremulant motor burst showing

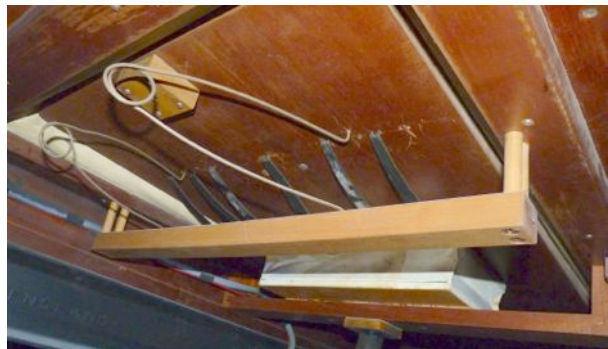
(R) Great Schwimmer altered

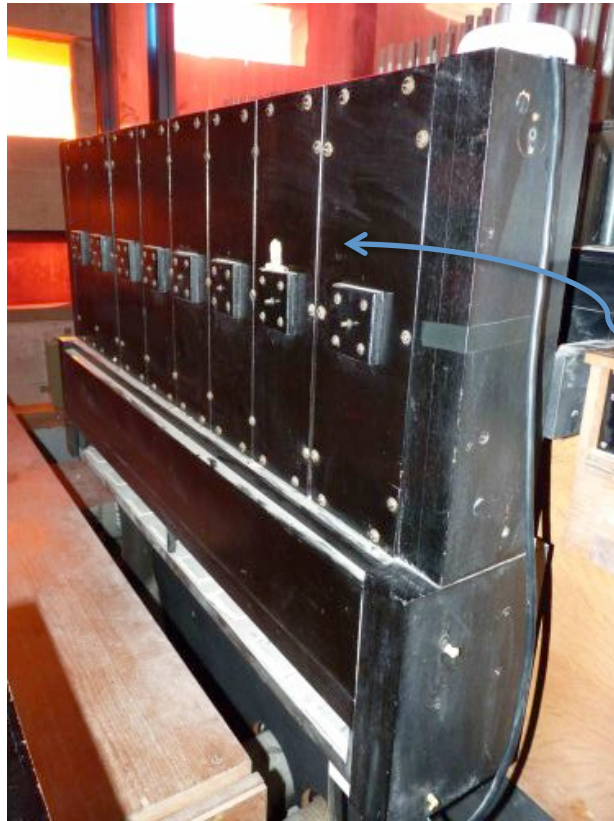
(L) Swell slider machine – worn out

4. Replace electro-pneumatic slider machines with electric solenoids (e.g. Taylor) with their own power supplies. These might need fitting through squares and mounted vertically as they will otherwise project further out than the slider machines.

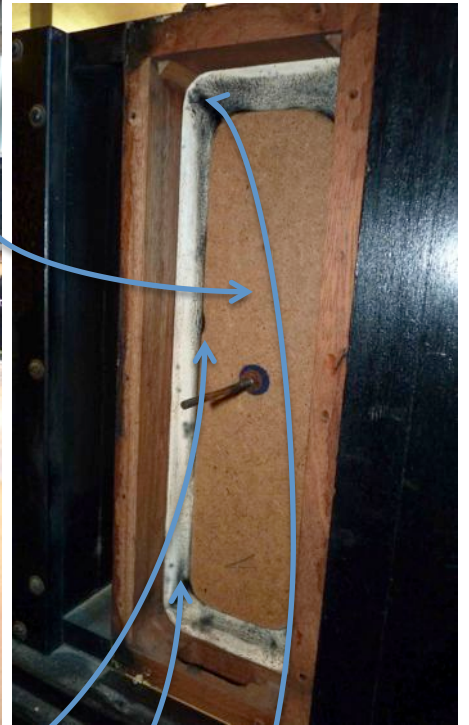
2. The leather which, together with a thin board, forms the 'pan' to put on or off a stop slider has perished and is leaking badly from the 'on' side to the 'off' side and vice versa, depending upon which side is charged. The leaking air then vents to the atmosphere through the exhaust valves, greatly increasing the leaking wind, the noise of which is now all too apparent.

(R) failed leather in one slider operating pan

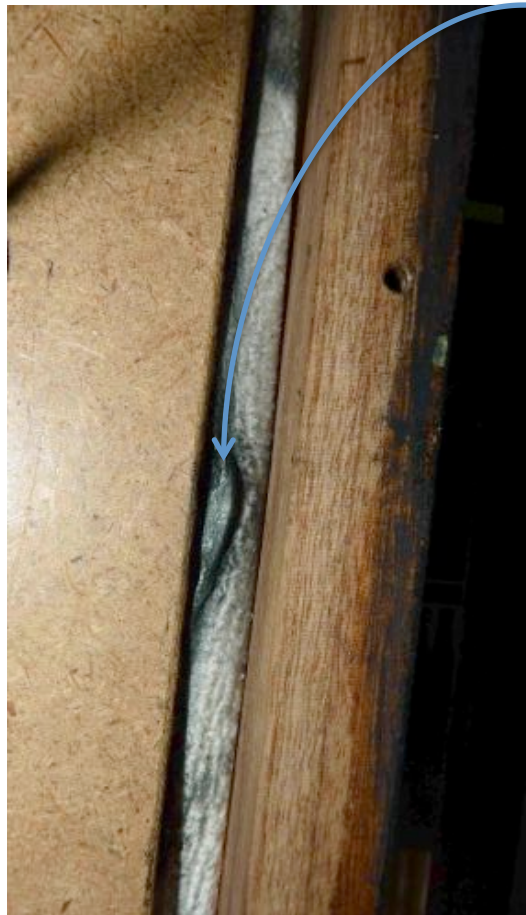
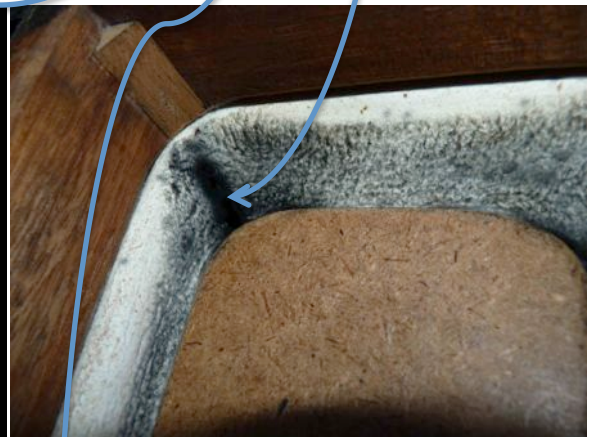
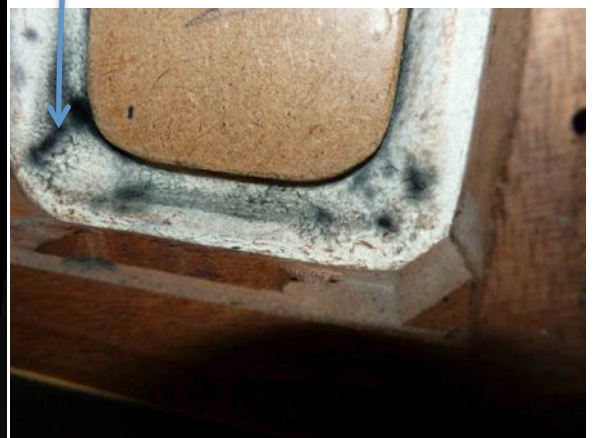
failed leather on edges of one slider pan (they are all in a similar condition)

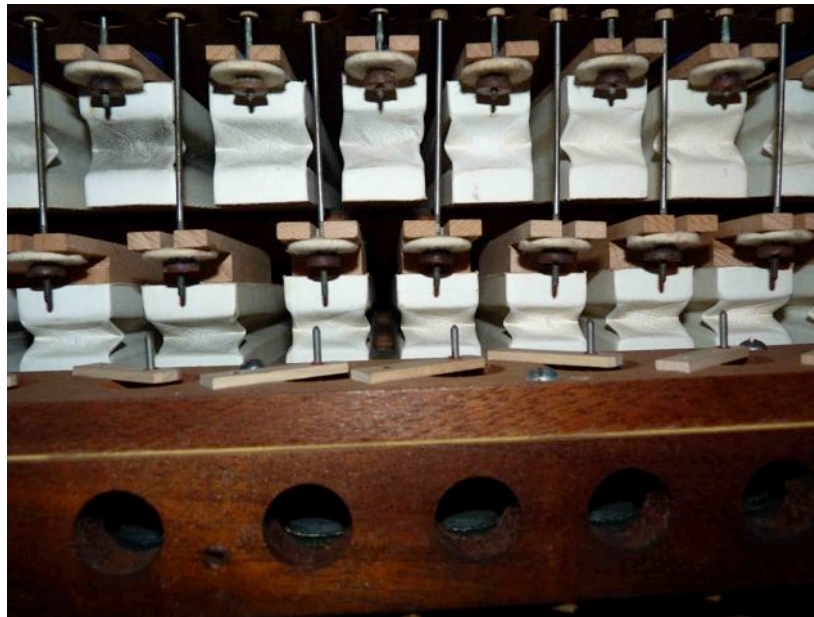
*Swell
soundboard
under-action
leather in
apparently
sound
condition*

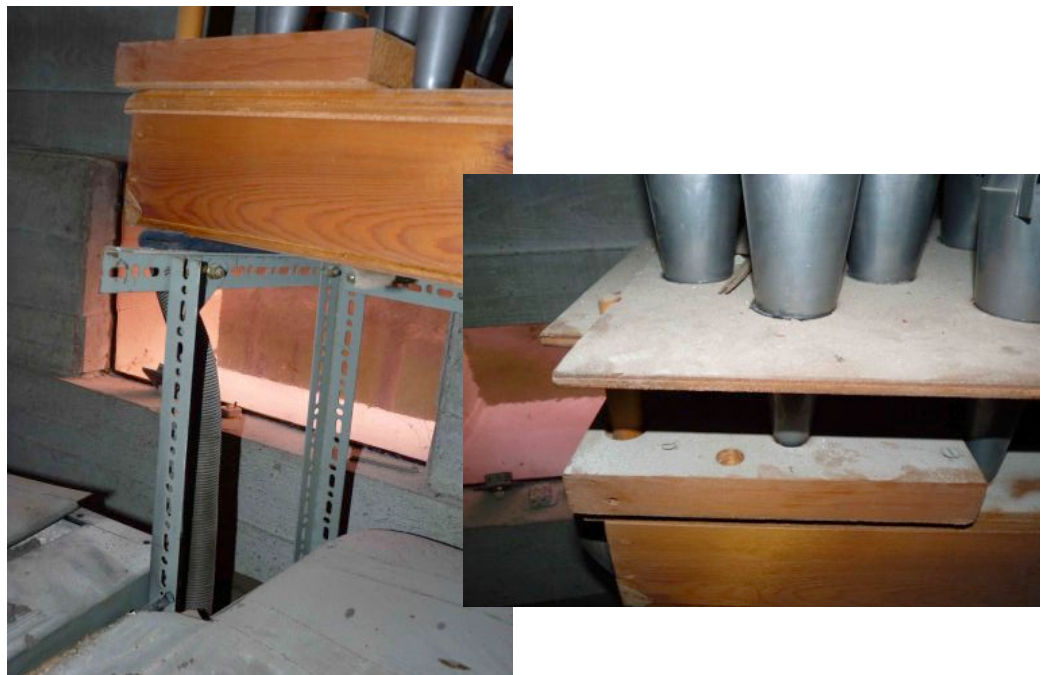
*1976
Flöte chest –
poor
structural
support &
construction;
out of
character
with the
organ*

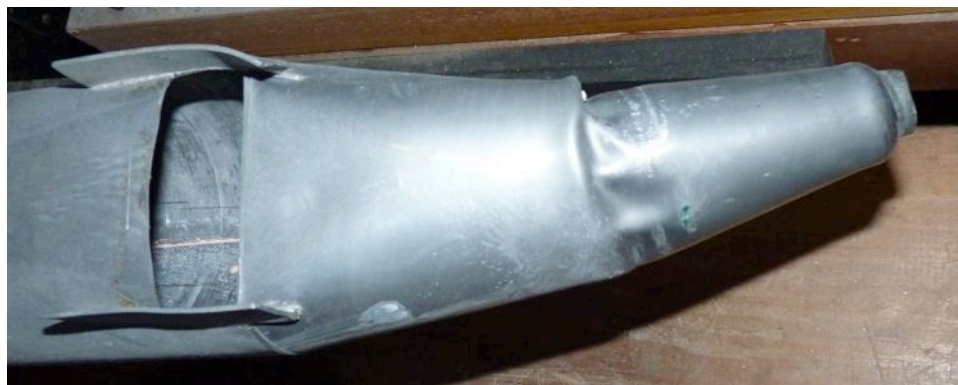
*distorted
foot of
bottom
note of Flöte
because of
poor
chest
construction*

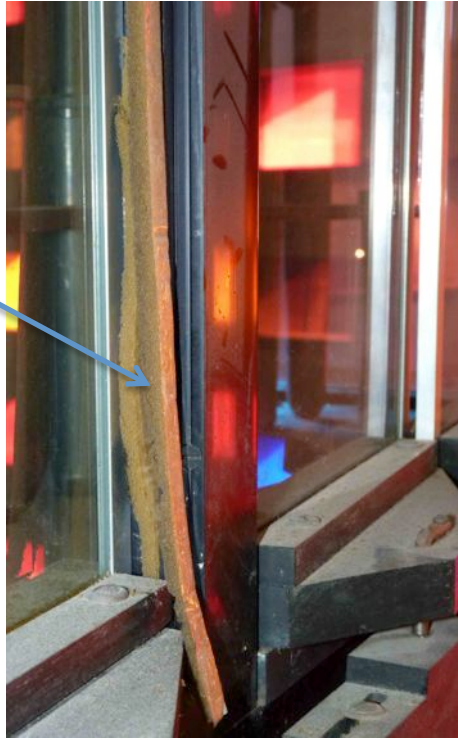
1. The glass panes are dirty and would respond to cleaning, after which they should be treated with some sort of dirt-repelling agent if such exists.
2. The Swell shutters clatter because the 'draft-excluder' strips on their leading edges have perished.

*(L) Swell shutter seals
perished
and detached*

1. Clean all glass extremely thoroughly and finish with a dust-repellent / antistatic agent, if such exists.
2. Refit Swell shutters with new strips of a soft edging material, to replace the perished draft-excluder presently glued to the leading edges. Discussion as to what this should be will need to take place. The challenge is to find something which will prevent the shutters banging when they close, will have sufficient 'give' to enable them to bed together when closed (acting as a sound-trap), to be as invisible as possible, and to be long-lasting. Though self-adhesive draft-excluding strip has the first three characteristics its foam material has a notorious short life-span and is thus not really appropriate for use in a structure for which a lifespan of decades is expected. On the other hand, it is fairly easily replaced in the future as the shutters can be reached from the front.

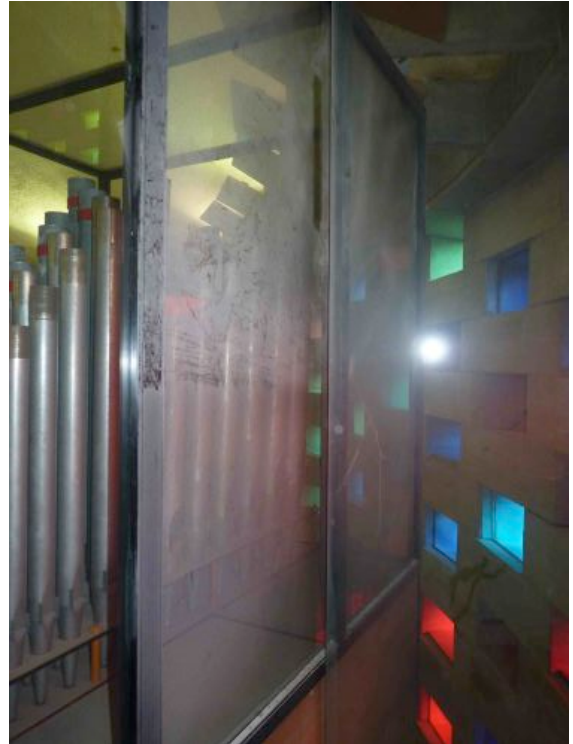
*(R) Grime on
the rear
of the Great
tone cabinet*

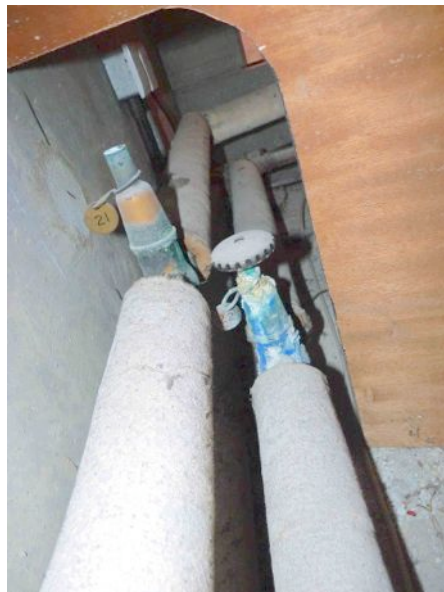
3. The Bowden-cable link to the swell shutters works well – probably because it is a short run.
4. The heating pipes, lagged though they are, which run underneath the Great soundboard, give off sufficient heat, especially around the exposed valve areas, to diminish the humidity in that part of organ significantly. It is no surprise, therefore, that the leatherwork on the Great Schwimmer and on the Tremulant motor is more perished than its equivalent under the Swell. This will also affect the tuning of the organ, as one side of the instrument will go out of tune with the other.

*(L) heating
pipes / valves
under Great*

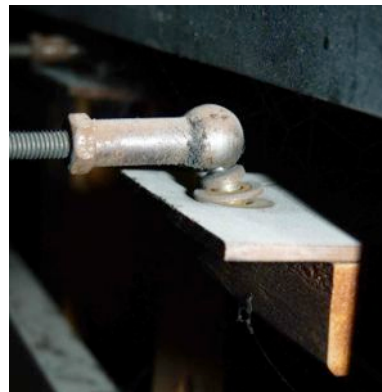
*(R) worn
connection
to a
Swell
slider*

5. Neatly plate over the trunk holes from the main supply, which currently feed the three [now redundant] slider-machines.
6. Remake the connections from the slider actions to the slides, as there is significant wear at this crucial place with lost motion in the connection.

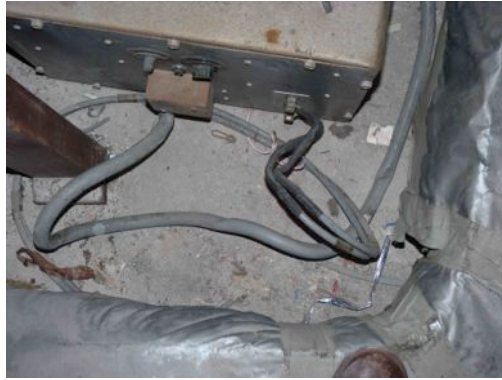
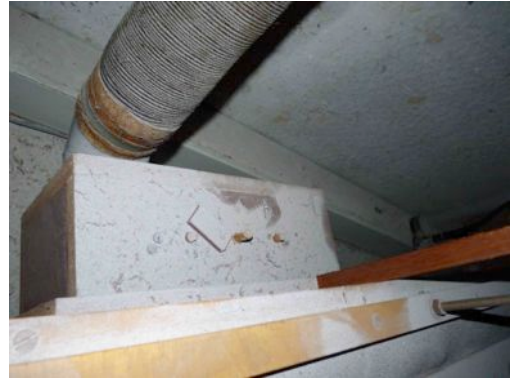
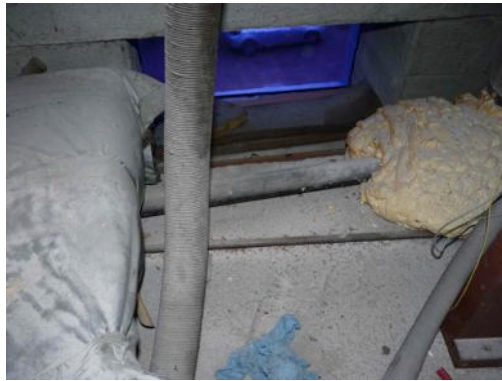
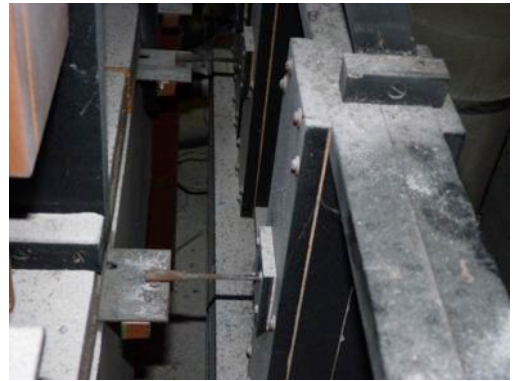
Dirt, dust and debris around the organ

The instrument is very dirty, the layers of deposit containing two elements: (1) 'historic' dust from skin and clothes laid down since 1966, and (2) a more recent and much more invasive thick layer of more abrasive debris which looks like dirty fragments of plaster or cement, sitting on all parts of the organ not enclosed in the two glass cases.

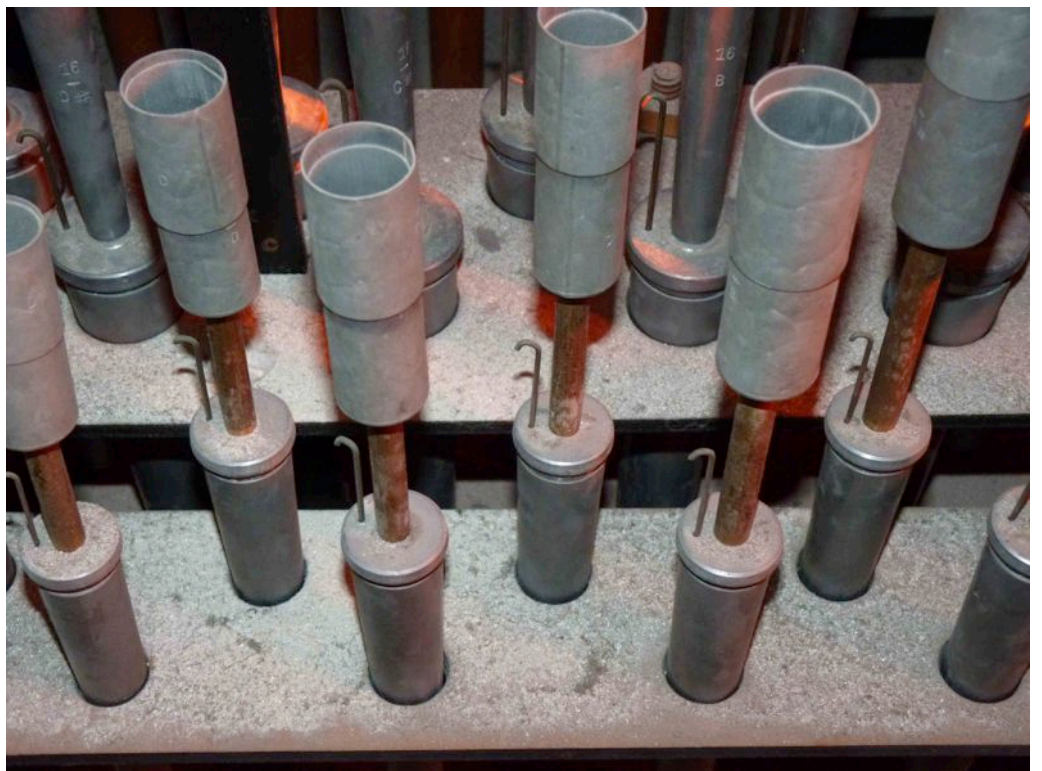
More serious invasive debris deposited in and around Pedal pipes
